Site Conservation during the Rescue Excavations

Roberto Nardi and Kristian Schneider

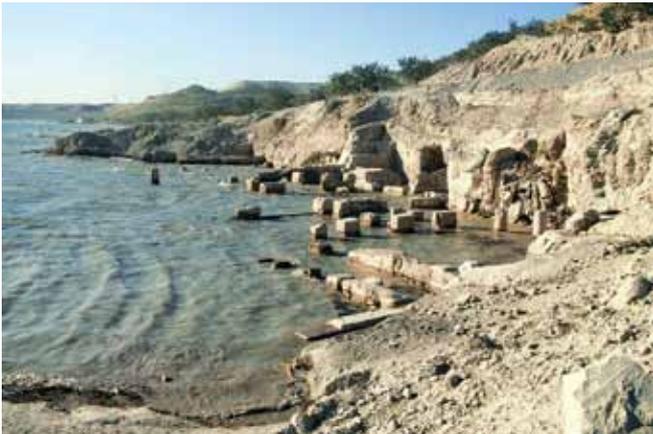
Figure 1. Area A being submerged without protective measures. View to east.

to inundation without any protective coatings or backfilling (figs. 1–4). As for the detachment of the 700 m² of mosaics prior to May 2000, this had been performed without systematic documentation, inventory, or written reporting and without the aid of professional personnel, but rather was done by untrained laborers employing haphazard methods. After detachment, some mosaics had been stacked outdoors in the courtyard of the Gaziantep Museum. During these operations, many mosaics were severely damaged, and some parts were lost altogether (figs. 5–6).

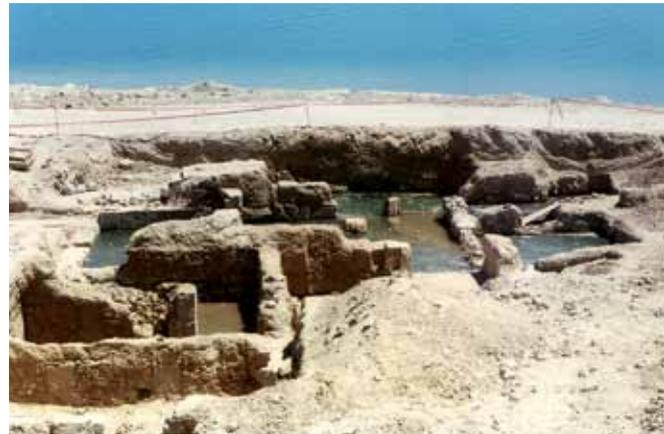
Figure 2. Area A being submerged without protective measures. View to north.

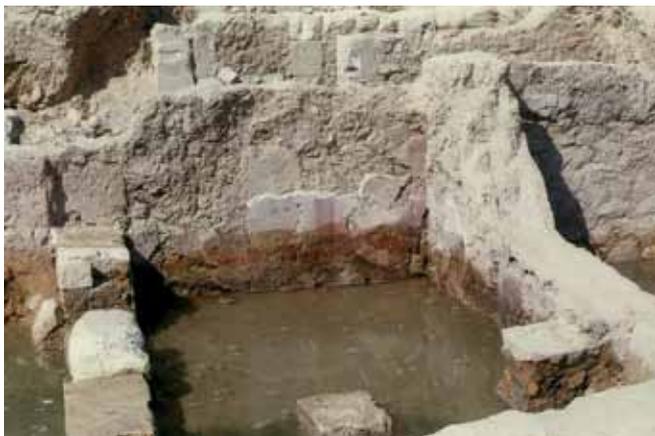
Figure 3. Area A being submerged without protective measures.

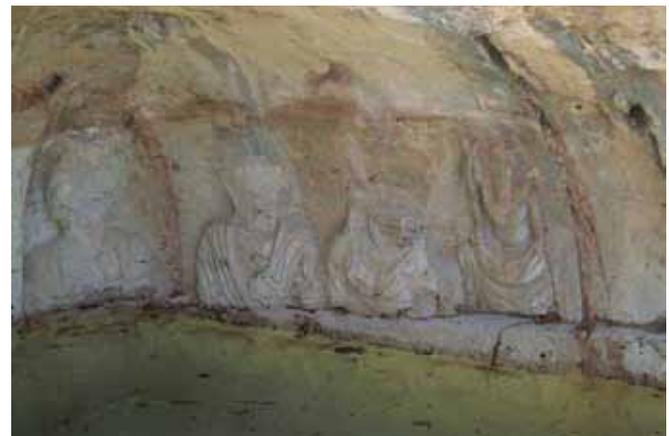
Figure 4. Area A being submerged without protective measures.

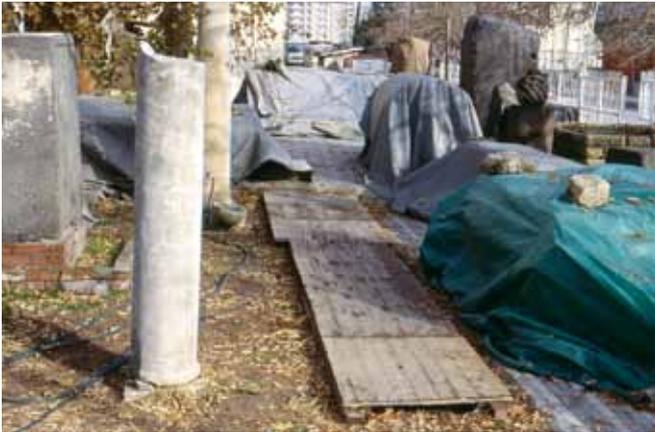
Figure 5. Mosaics stored under tarps outside at the Gaziantep Museum, prior to the PHI rescue project.

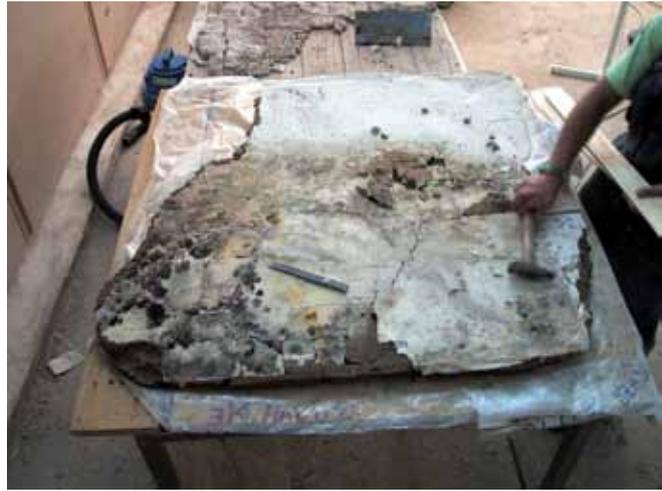
Figure 6. An uninventoried mosaic fragment removed from Zeugma prior to the PHI rescue project, showing deterioration, cracking, and staining.

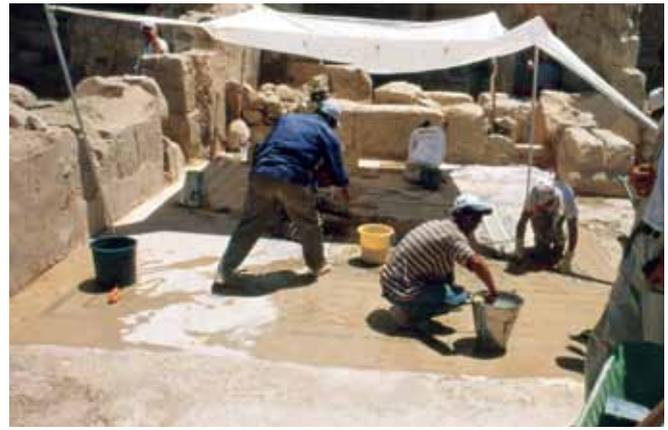
Figure 8. Shaded work areas to mitigate crystallization of salts on artifact surfaces.

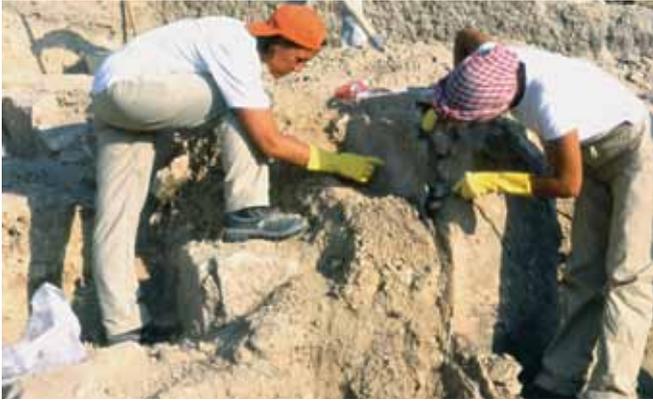
Figure 9. Layer of original soil left on the surface of mosaics and painted plaster.

In their rescue work on the site, archaeologists were given technical advice about how to prevent damage to surfaces and objects during their work. With temperatures ranging between 40° and 50° C, newly uncovered structures and finds were threatened by rapid evaporation, which often leads to damaging crystallization of soluble salts. This causes loss of surface layers and micro-structural damage through capillary cracks, as well as the formation of insoluble deposits that obstruct visibility of the object surface (fig. 7 a–c). Work areas were shaded to mitigate this phenomenon (fig. 8). In the case of mosaics and painted wall plaster, archaeologists were instructed to leave a 10-cm

layer of the original earth on the object. This protective earth layer was removed by conservators with soft plastic brushes, synthetic sponges, a 2 percent solution of NeoDesogen in water, and a vacuum cleaner for liquids (figs. 9–12). Cleaning was carried out with a high ratio of person to object surface in order to reduce time of exposure of untreated surfaces to heat and air, and to prevent the formation of insoluble layers on surfaces (fig. 13).

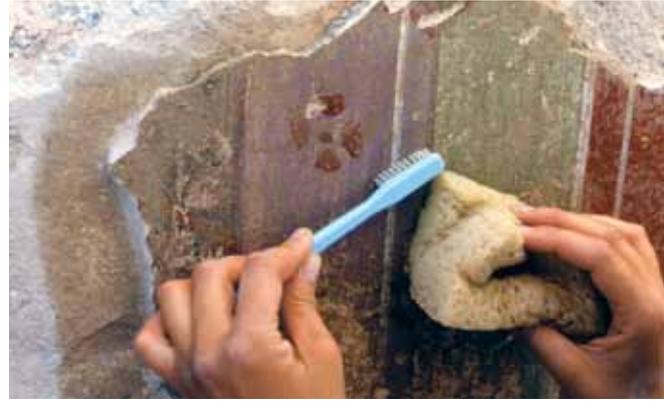
Figure 12. Cleaning performed with soft plastic brushes, synthetic sponges, a 2 percent solution of NeoDesogen in water.

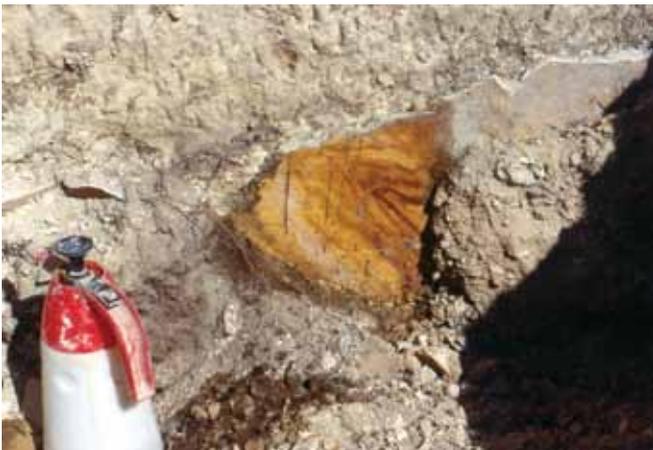
Figure 10. Cleaning performed with a 2 percent solution of NeoDesogen in water and a vacuum cleaner to remove liquids.

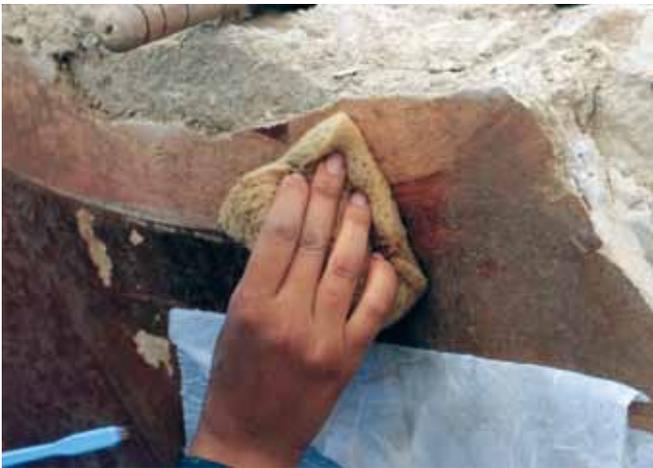
Figure 11. Cleaning performed with soft plastic brushes, synthetic sponges, and a 2 percent solution of NeoDesogen in water.

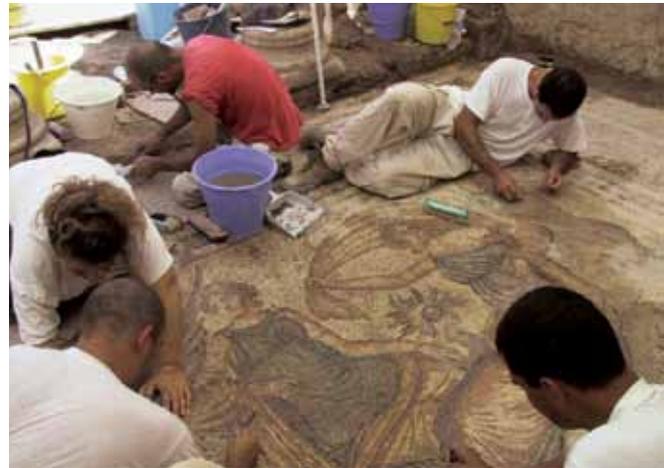
Figure 13. Cleaning carried out by a large team in order to reduce the time of artifact exposure to heat and dry air. Trench 11, M23.

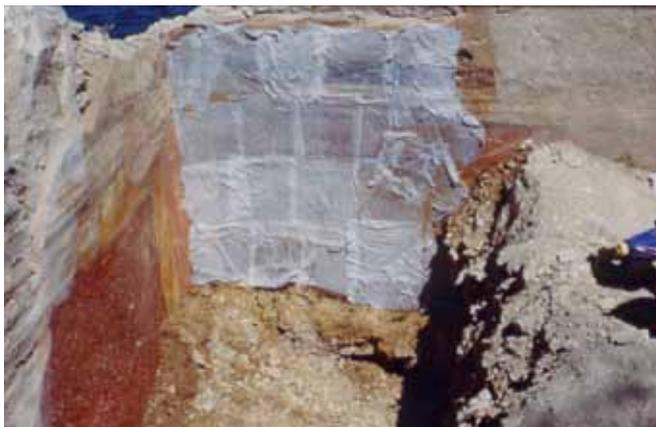
Figure 14. Wet tissue paper applied to painted plaster as a deterrent to damaging soluble salts.

In the case of painted wall plaster, vaporized water applied with hand-held sprayers was used to soften the layer of protective earth, which was prone to rapid drying by exposure to air and high ambient temperatures. The removal of the protective earth layer was accomplished with scalpels up to the final layer in direct contact with the original painted surface. After complete removal of the protective earth layer, drying of the original painted surface was controlled by the application of tissue paper wetted with water to serve as a safe repository on which remaining soluble salts crystallize (fig. 14).

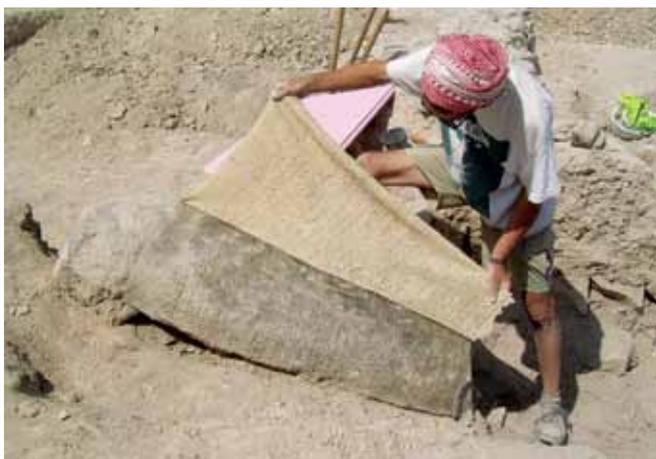
Figure 15. Preparing the inscribed stele of Antiochus I (ss1) for a latex cast.

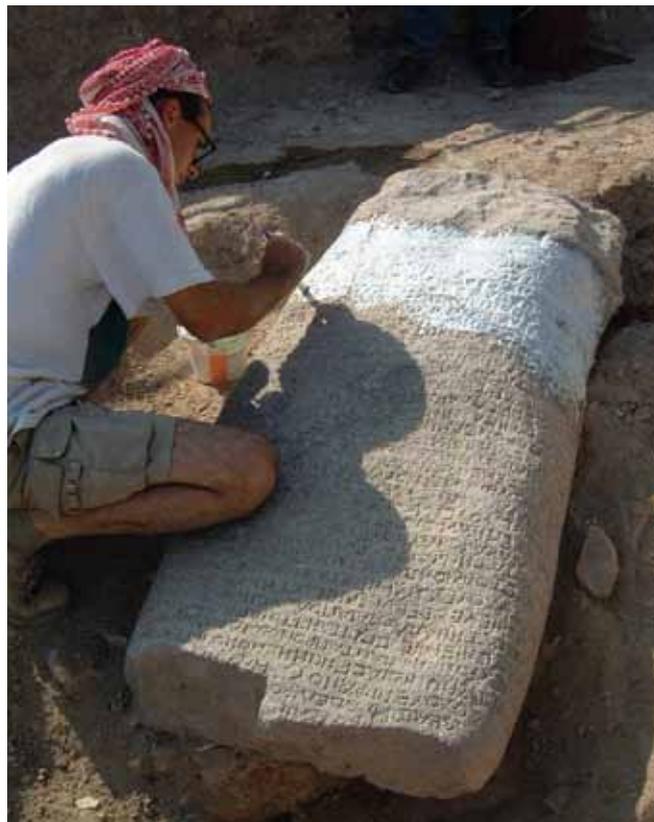
Figure 16. Adding a latex cast to the inscribed stele of Antiochus I (ss1).

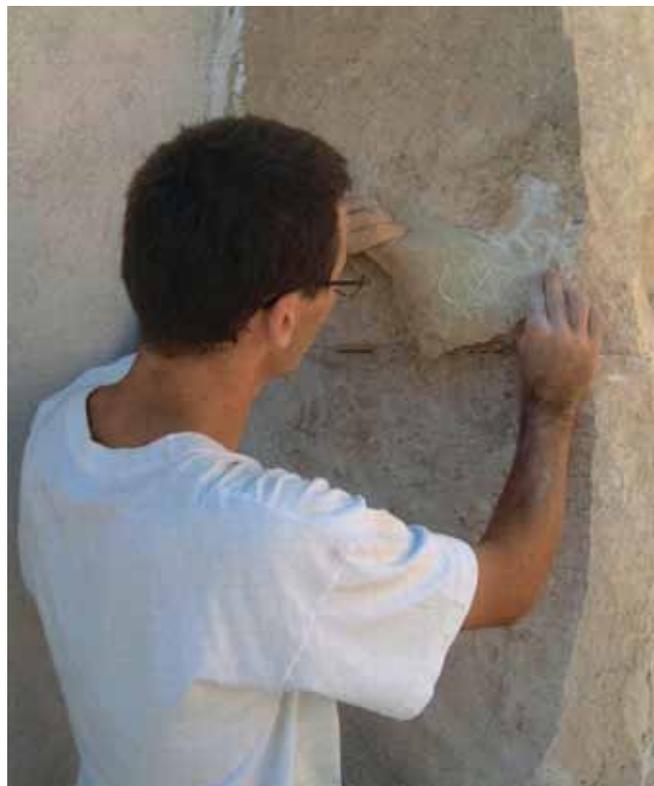
Figure 17. Removing a latex cast from a graffiti on painted plaster.

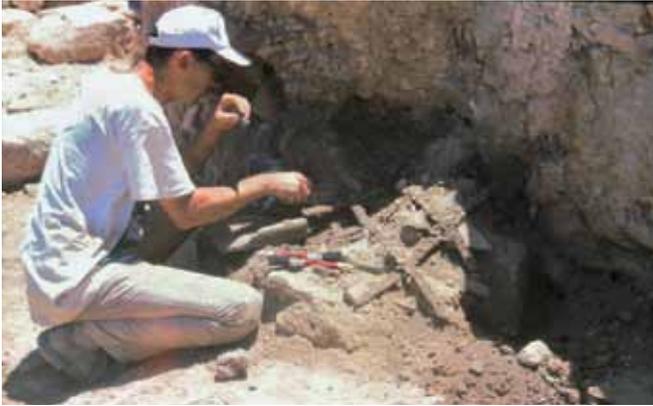
Figure 18. Block-lift for large iron objects in preparation.

In the case of large or fragile objects, a block-lift was used by the conservation team (figs. 18–19). This entailed the removal of the artifact in a semi-excavated state, with the original soil still surrounding it. In the case of compact, fairly humid soil conditions, use of a flat and rigid board inserted under the object was sufficient, followed by the stabilization of object and soil with the application of transparent plastic foil or aluminum foil. Layers with debris from destroyed buildings were often encountered at Zeugma, and this meant the discovery of objects within loose and fragile soils with a high rubble content. In these cases, the object to be recovered was first partially excavated and then protected with transparent foil. The

foil covering was then encased in a block of polyurethane foam rigid enough to be lifted safely after the foam had set. For every block-lift, a recovery record sheet was filled out to keep track of all materials used. This was necessary for identifying materials that might have come into direct contact with the artifact, thereby potentially interfering with further archaeological inquiry or conservation treatment. Furthermore, a hand-drawn sketch was made to record the exact position of all lifted fragments.

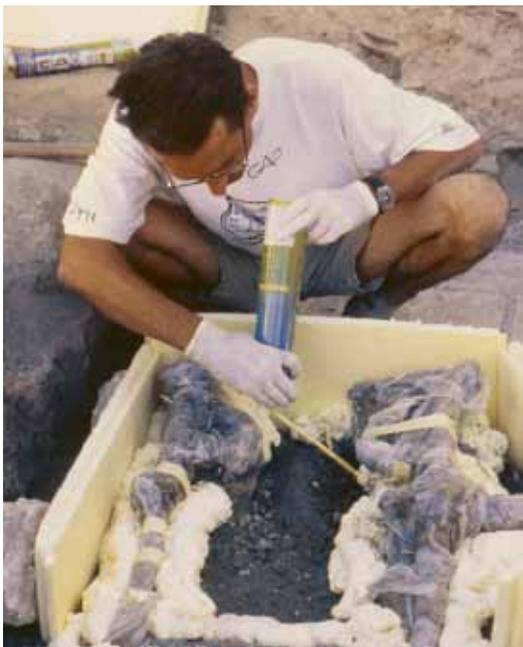
Figure 19. Block-lift for large iron objects in preparation.

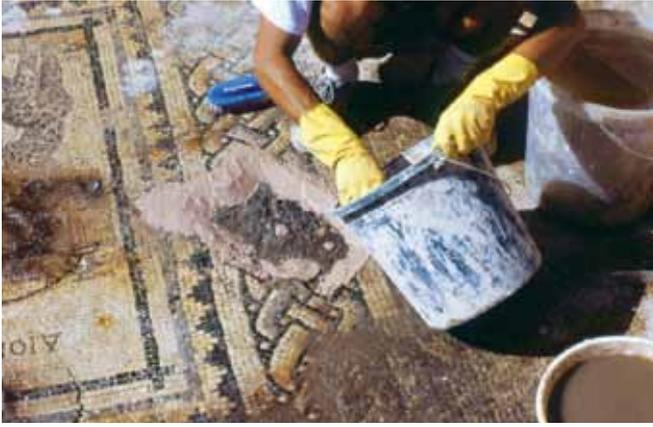
Figure 23. Edging of a lacuna on a mosaic on site.

hydraulic lime composed of sifted stone dust, brick dust, and Lafarge hydraulic lime (ratio 1:1). This operation was performed to affix loose tesserae to the original bedding layer and to consolidate the edges of lacunae (figs. 23–25).

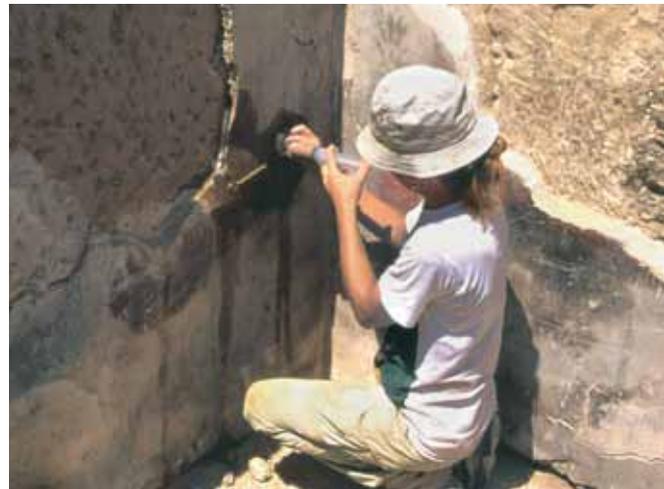
Figure 27. Deep grouting of painted plaster with hydraulic lime and brick powder.

In the case of painted wall plaster in imminent danger of crumbling, temporary props were built. Areas at risk were secured with cotton gauze linings applied with high-concentration acrylic resin (Acryloid in acetone, 15 percent), and exposed areas were consolidated. Where layers of painted plaster had separated, injections with hydraulic mortar made with sifted brick dust and Lafarge hydraulic lime (ratio 1:1) were used for consolidation. Lacunae and edges were also reinforced with hydraulic mortar made of stone dust and applied with spatulas. This involved the mechanical removal of accumulations of dirt and roots along edges and in lacunae using scalpels and a vacuum. This was followed by the edging of borders and lacunae with a lime-based mortar made of Lafarge hydraulic lime, slaked lime, sifted brick dust, and limestone dust in a ratio of 0.5:0.5:1:1 (figs. 26–27).

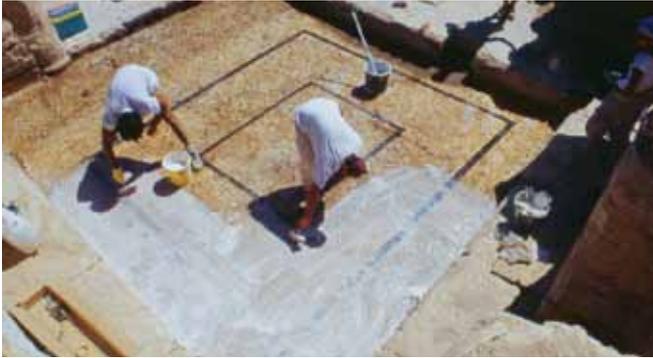
Figure 28. A layer of lime-wash applied to the surface of a mosaic. Trench 2, mosaic M14.

A coating of lime-wash was brushed directly onto the cleaned and consolidated surface of mosaics and painted plaster. This coating had the double function of further

consolidating the artifact surface and acting as a buffer between the original surface and subsequent layers of protection, thereby making the latter easier to remove in the future (figs. 28–29). After this lime-wash had dried and set, the protective layer was applied. This was a 5-cm-thick layer of hydraulic mortar composed of Lafarge hydraulic lime, slaked lime, brick powder, and stone dust in a ratio of 0.5:0.5:1.5:0.5 (fig. 30). This layer was extensively worked to obtain full adhesion to the surface beneath it and to improve the carbonation process of the mixture’s aerial components (figs. 31–34). This “sacrificial” coating was designed to protect the artifact from mechanical stresses of the reservoir’s fluctuation zone. Moreover, the hydraulic properties of the mortar slow the saturation process and prevent an abrupt soaking. In addition, the hydraulic properties of this mortar induce a continuous hardening during submersion and therefore an improved resistance of the material to mechanical stress over time.

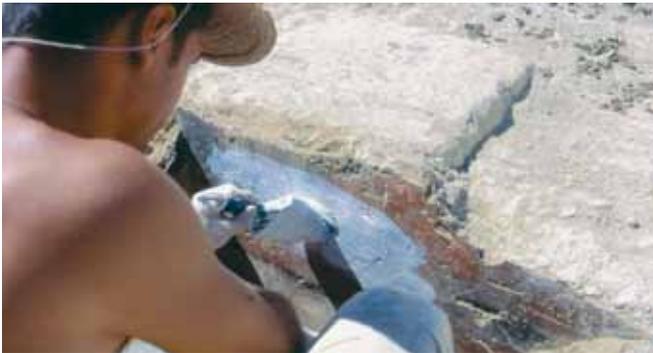
Figure 29. A layer of lime-wash applied to the surface of mosaics and painted plaster.

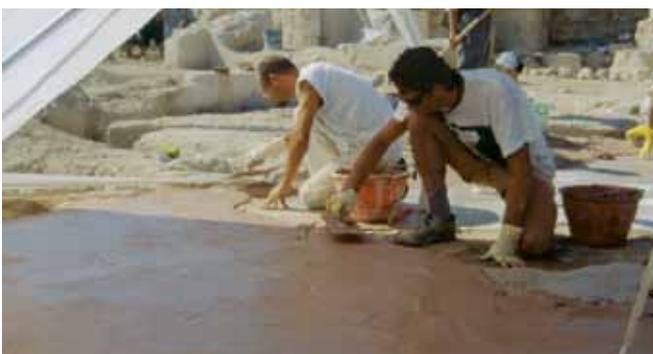
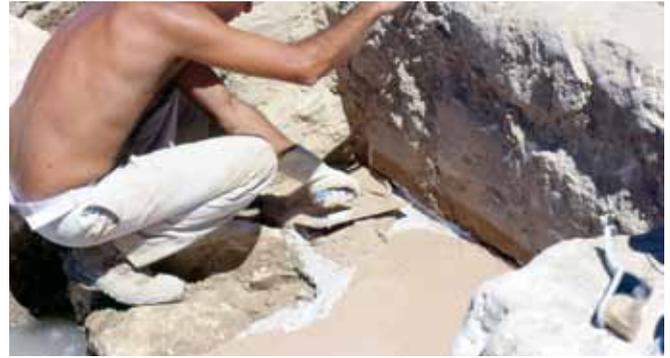
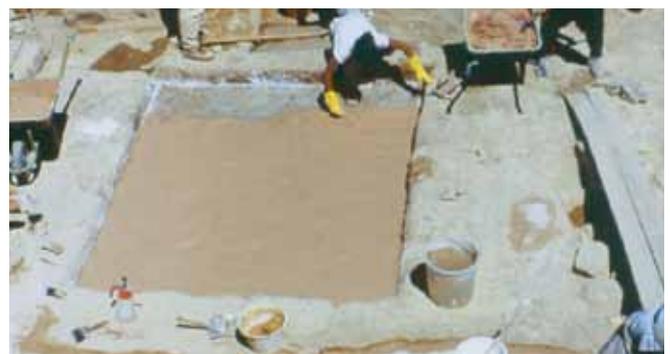
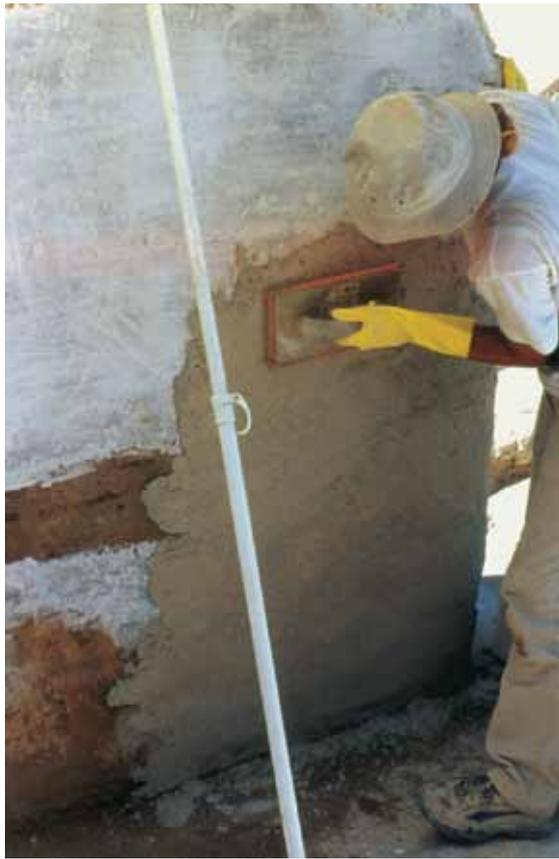
Figure 32. Lime-based hydraulic mortar is applied once the lime-wash undercoating has set.

Figure 31. Lime-based hydraulic mortar is applied once the lime-wash undercoating has set.

Figure 33. Lime-based hydraulic mortar is applied once the lime-wash undercoating has set.

Figure 34. Lime-based hydraulic mortar is applied once the lime-wash undercoating has set.

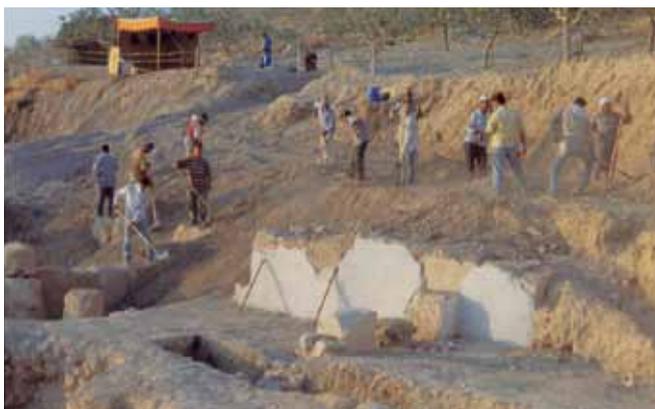
Figure 36. A protective layer of soil is put in direct contact with archaeological features already coated with protective mortar.

was determined by the topographical features of the individual “trench environments” (fig. 35). In gently descending valleys, a simple soil and sand filling was sufficient, but trenches on steeper ground required heavier sealing materials. Here, soil and sand were still used to pack the structures tightly to prevent damage, and gravel and stones were used above this to hold the underfilling in place and resist the wave action (figs. 36–37).

The soil and sand placed in direct contact with archaeological features was humidified and compressed in order to avoid shrinkage when soaked with water. Special care was taken to fill all cisterns and rock-cut rooms to prevent cave-ins and settling. These operations were carried out by hand using wheelbarrows and shovels. Remaining backfill operations were carried out with machinery wherever possible. Where terrain was difficult, materials were brought as close as possible to the trenches by mechanized transport, and then distributed by manpower. Once all the structures in the trenches were covered with soil and sand, the backfill was sealed with gravel and stones. Generally, we aimed for a covering of at least 50 cm above the top of the soil fill. In the case of gentle slopes, the gravel and the stones were mixed, while on steep hillsides the stones were distributed

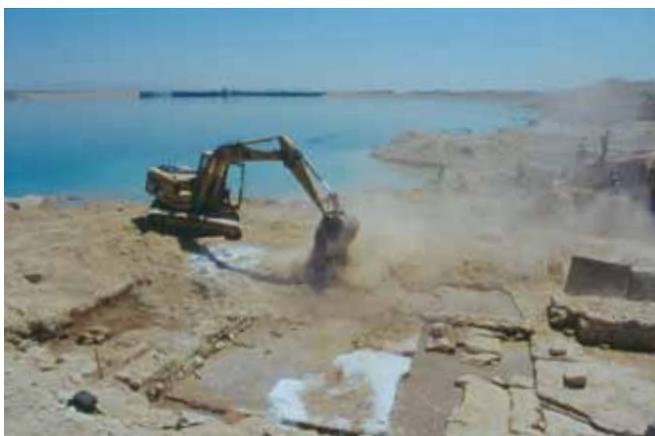
Figure 37. A protective layer of soil is put in direct contact with archaeological features already coated with protective mortar.

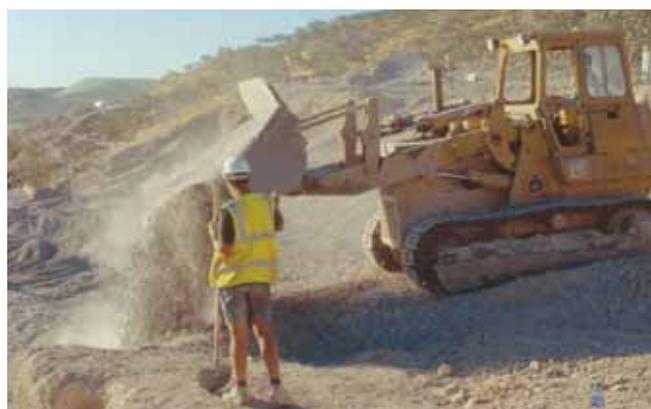
Figure 38. Once the archeological remains are covered, the reburial is completed with gravel and stones.

as a separate layer above the gravel. This had the effect of a natural filter, whereby the larger elements held the smaller particles in place and kept them from being washed away (figs. 38–39). A total area of 8,700 m² was reburied, covering 18 excavation areas.¹² The volume of materials used for reburial was 10,500 m³, and of this, 6,300 m³ (equivalent to 630 truckloads of sand, pebbles, and stone) was brought in from off site.

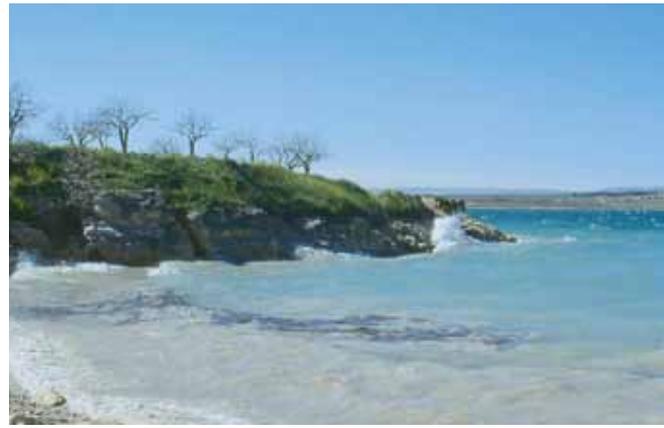
Figure 41. Tall waves now splash against the shoreline on a windy day.

led to the recovery, but more often loss, of archaeological remains brought to the surface. In some cases, walls and floors protected with hydraulic coatings during the project were exposed, but these have proven to withstand the conditions of the fluctuation zone. Newly exposed structures did not fare so well, and these had little or no resistance to erosion on the shoreline. Walls collapsed and floors were undermined. It was clear that further protective measures were necessary to minimize damage to the newly exposed archaeological materials in the fluctuation zone (fig. 41).

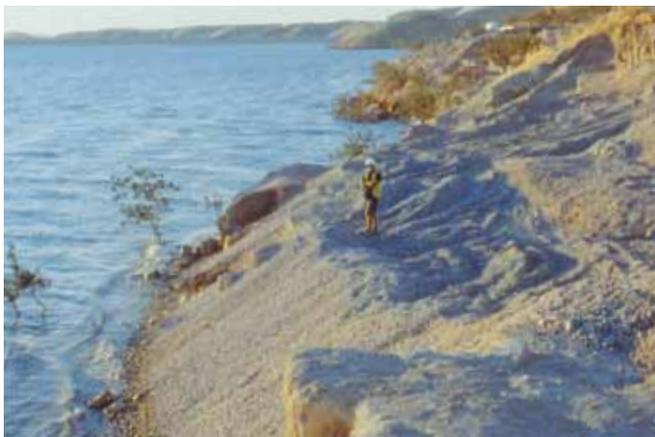
Figure 39. Once the archeological remains were covered, the reburial was completed with gravel and stones.

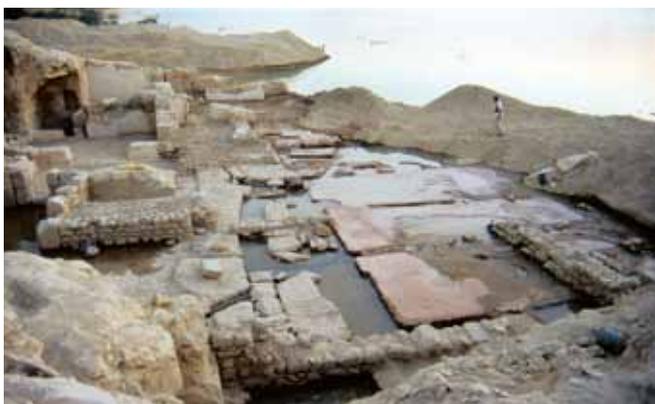
Figure 40. Trench 6, view to northwest, where reburial was not implemented and the structures were inundated with only hydraulic mortar for protection.

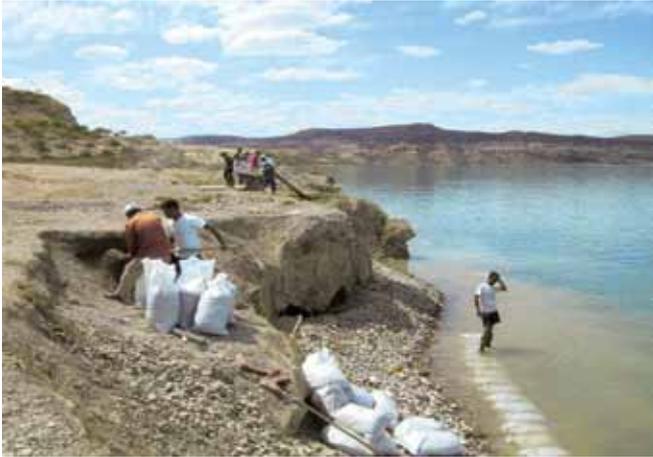
Figure 43. Positioning the bags filled with gravel.

To improve the efficiency of the protective system put in place immediately following the excavations in October 2000, the following measures were implemented. Rows of woven plastic (nylon) bags filled with gravel (10–30 mm diameter) were arranged parallel to the shoreline. These were stacked according to the slope of the shoreline, between two and four bags high. The nylon bags do not last well outdoors because they are susceptible to UV radiation, so the uppermost rows of bags were filled with gravel mixed with cement. Behind this barrier, heavy stones (100–200 mm diameter) were filled in up to the high-water mark observed during storm conditions. Where the shoreline configuration allowed it, a double row of bags was arranged 2–5 m apart. The space between the rows of bags was filled

with pebbles (figs. 42–43). After one month it was clear that the material of the bags was insufficient as a protective device. The plastic deteriorated quickly, spilling the fill into the water and polluting the environment. It was therefore decided to employ locally available, biodegradable canvas sacks. The life-span of these canvas sacks was intended to correspond to the time required for the gravel/cement mixture inside to dry and take its final form.

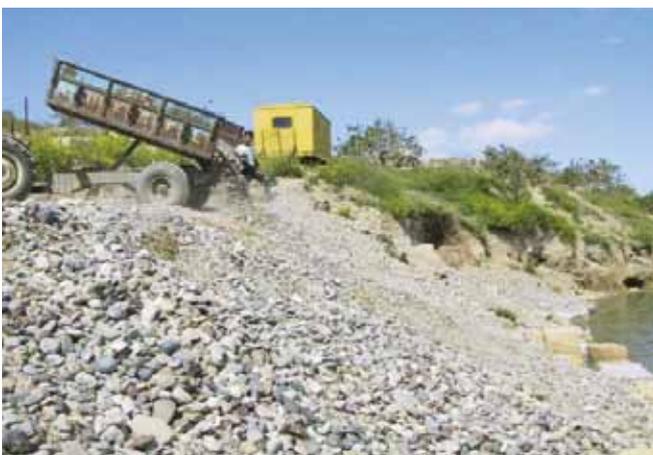
Figure 44. Filling in the terrain behind the bags with stones.

These protective measures were carried out with local manpower, using tractors equipped with dump-load trailers, under the supervision of conservation professionals. A total of 5,000 bags and 85 truckloads of pebbles (equivalent to 850 m³) were used (fig. 44).
